Eastern Region Initiative on the Clinch

A USGS Partnership to Investigate Effects of Water Quality on Freshwater Mussel Health in the Clinch River Basin in Virginia and Tennessee

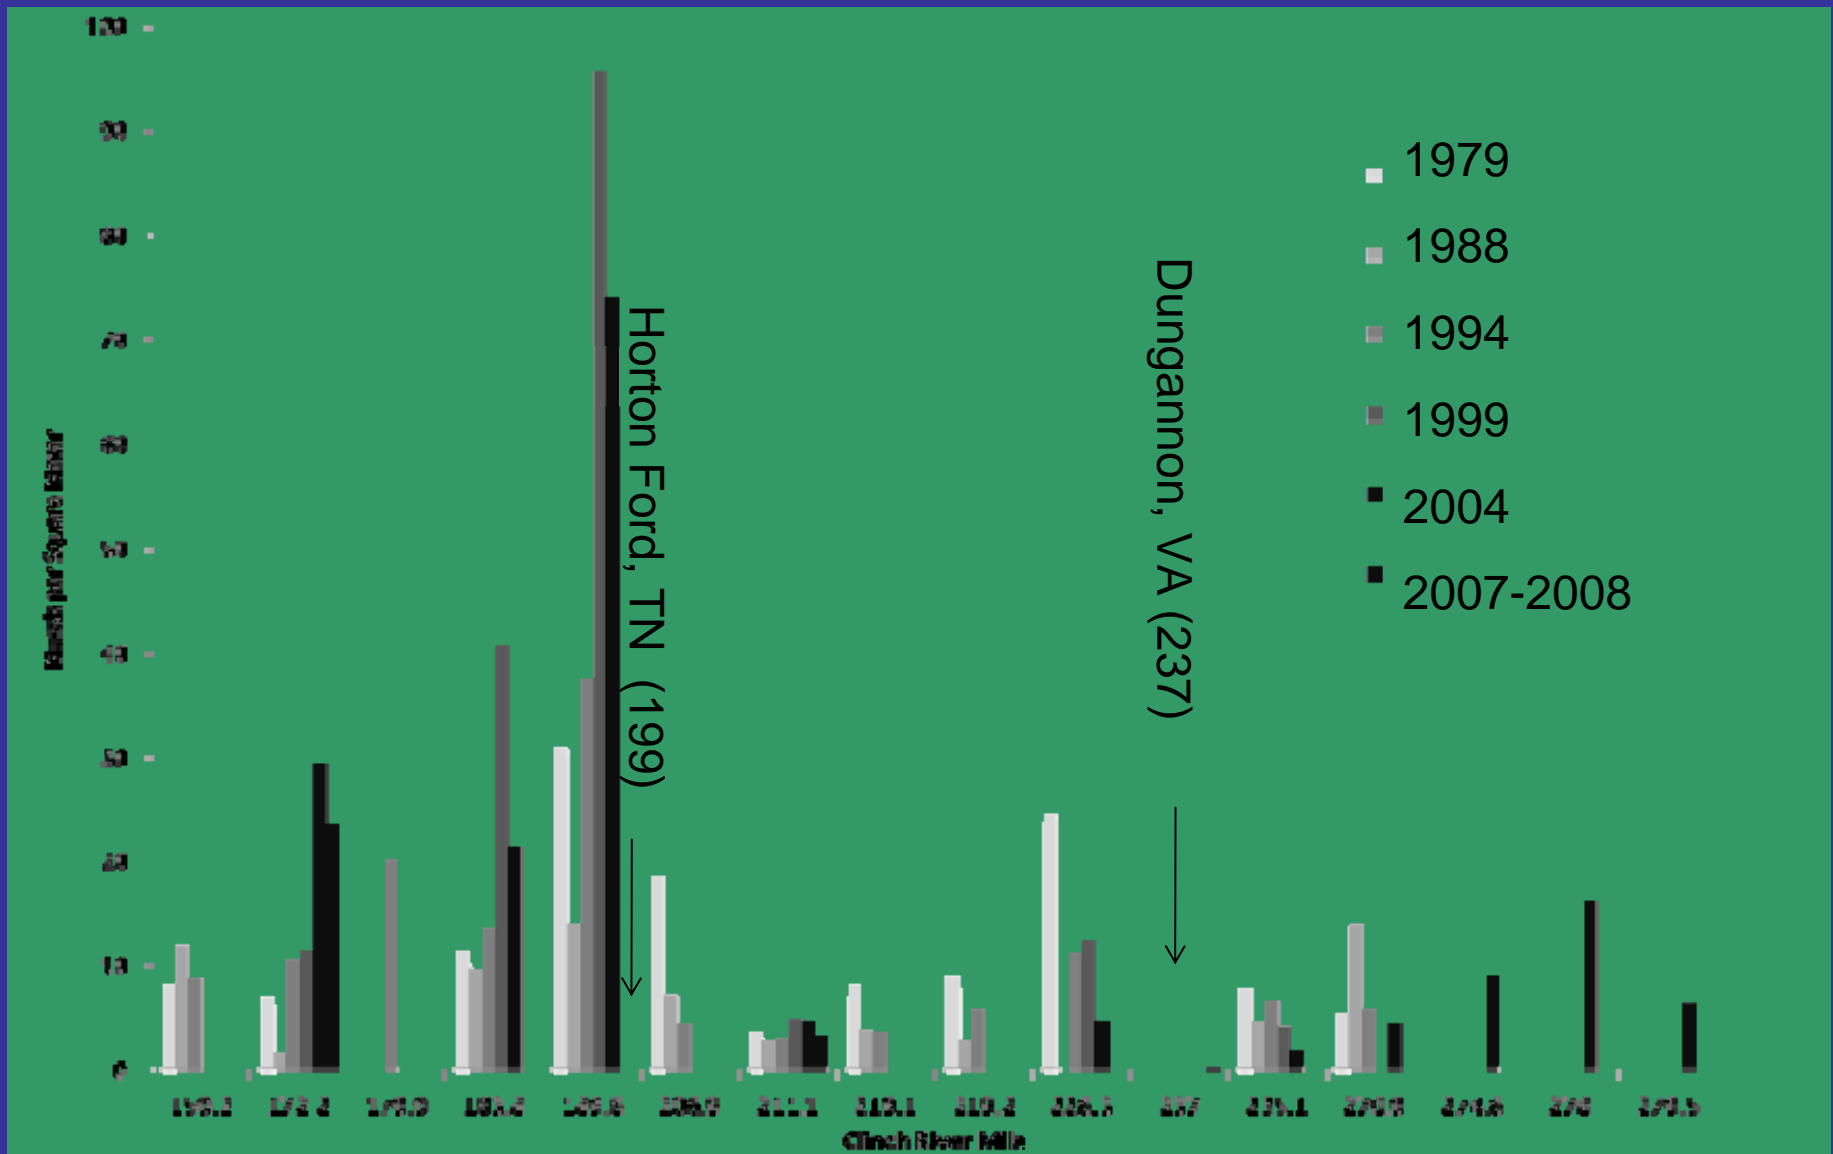
Changes in Mussels Density (mussels/m²) 1979 - 2008

Data from various studies: Ahlstedt and Otsby 1979 - 2008

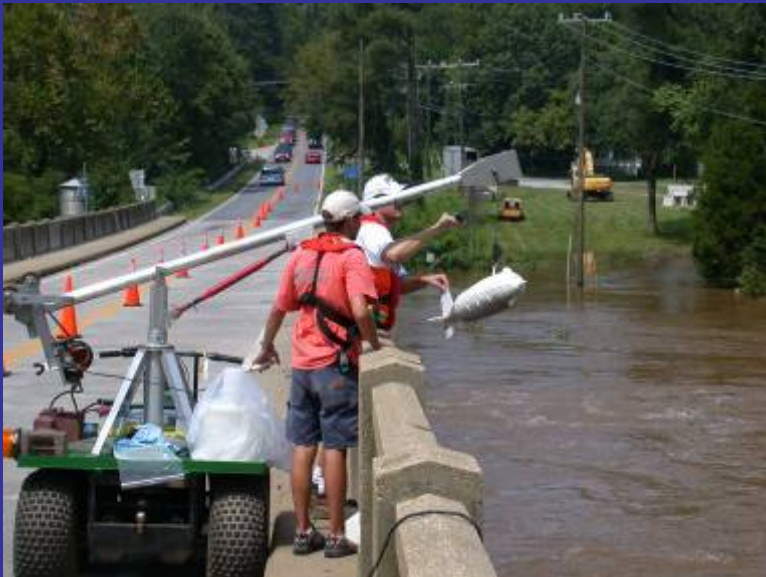
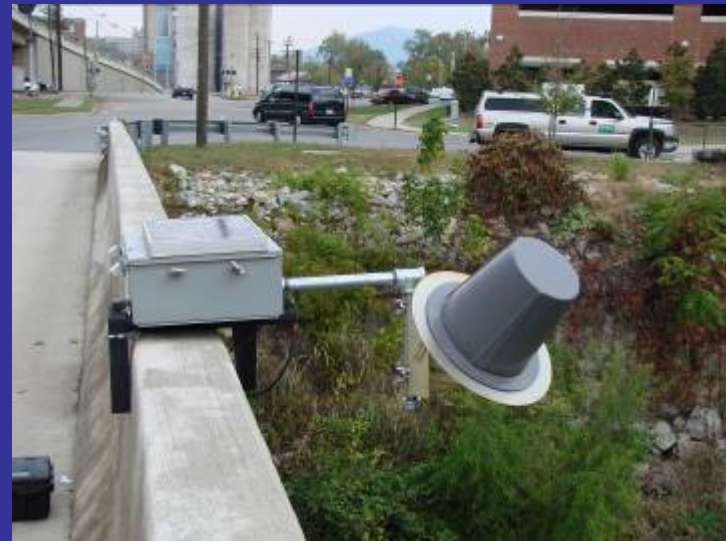
- Real-time Continuous QW at 2 Sites:
 - Temp, pH, SC, Turbidity
- Manual Storm Water & Suspended Sediment and Base flow Sampling
- Laboratory Analysis for Metals, Nutrients, Organics

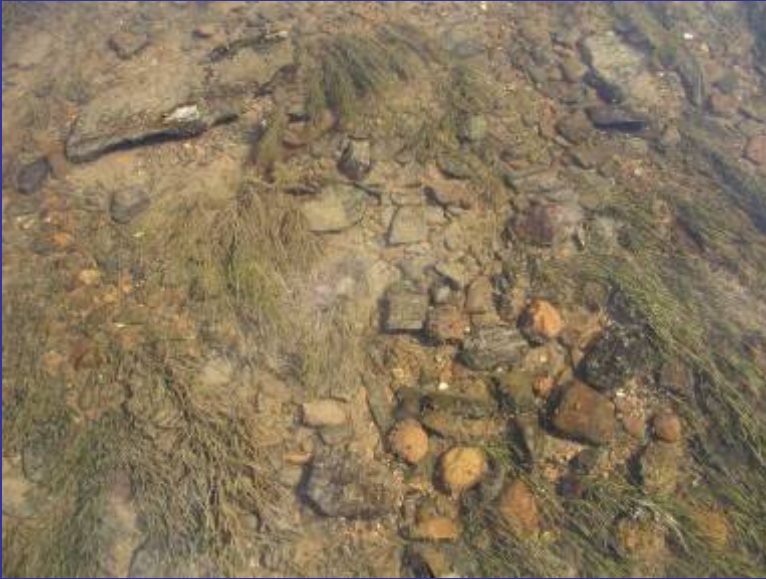
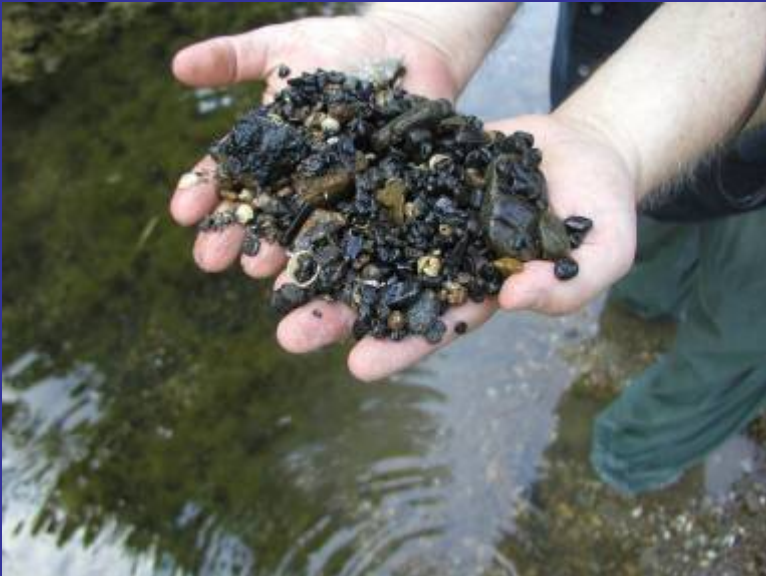
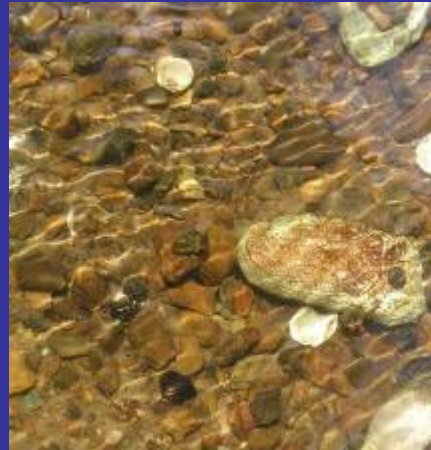
- Organic analysis
- Substrate size distribution
- Percent coal
- Fine sediment toxicity analysis (Ingersoll*)

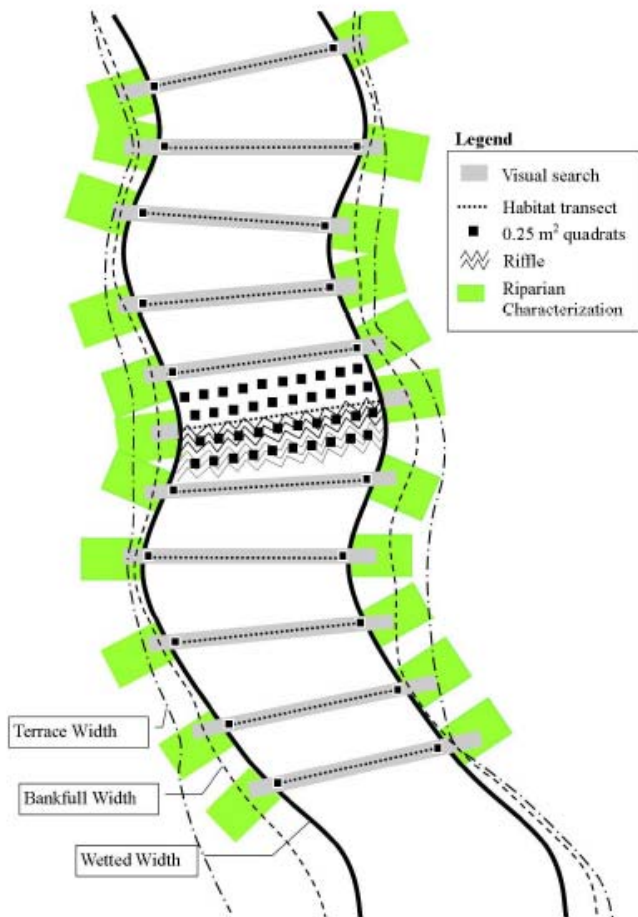
Figure 3. Mollusk and habitat assessment sampling design. All measurements within a 10x width reach.

(10x stream width in total)

Measure depth, substrate roughness, and substrate particle size.

Visually estimate silt depth and embeddedness.

Measure bank slope, bankfull height, terrace height, and riparian and instream cover, and reach slope.

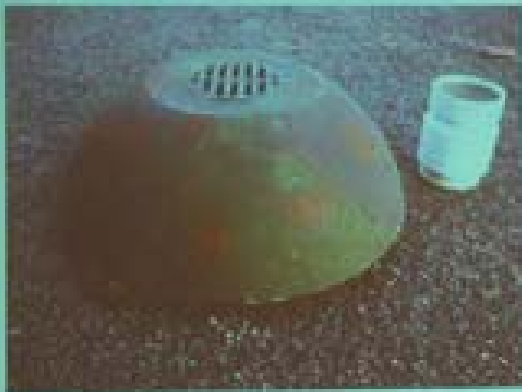
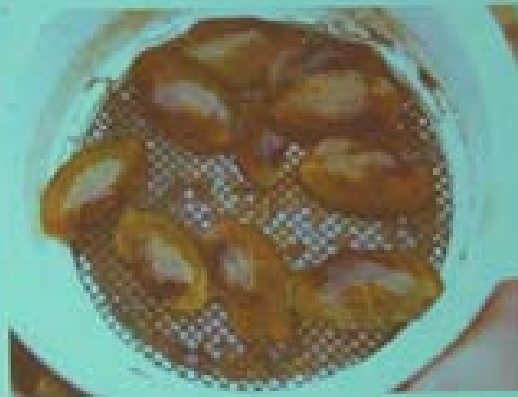
Mussel silos: Bernoulli flow devices for caging juvenile mussels in streams.
